TEST REPORT NO. 3078155

**INSPECTION, TESTS AND EVALUATION
OF**

RUBBER SLATE

**UL 2218 - May 31, 1996 (Revision: January 25, 2002)
IMPACT RESISTANCE OF PREPARED ROOF COVERING MATERIALS**

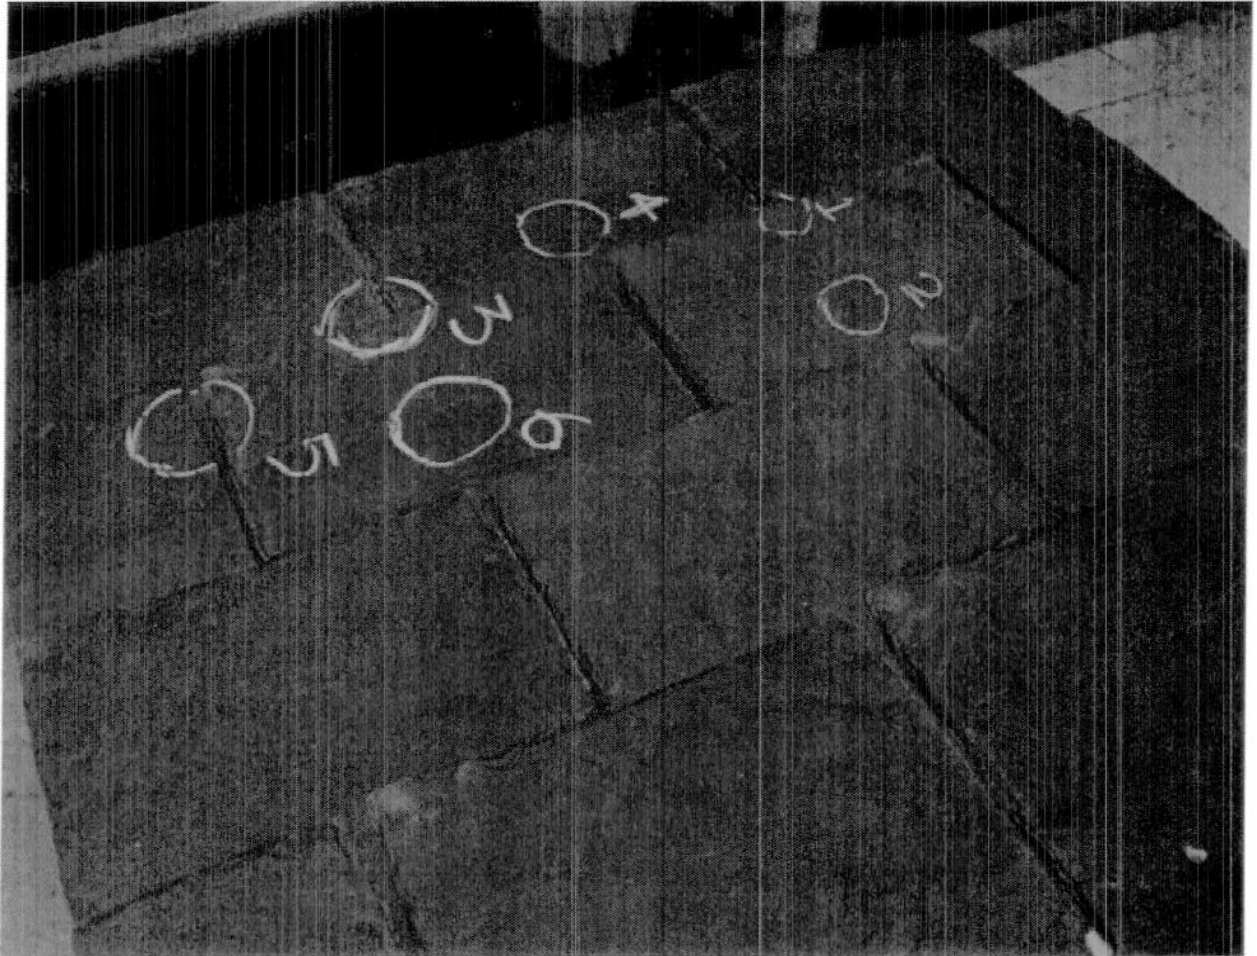
APPENDIX 1
LOCATION OF IMPACT

Testing was done in accordance with UL 2218 using the requirements of Class 4 in section 5.4. Class 4 specifies two coincident impacts from a 2-inch diameter steel ball, dropped from a height of 20 feet above the test sample. Six impact locations were selected on the prepared sample including those determined as being the most vulnerable. Refer to data sheet in Appendix I for Drop Locations.
